Manhole Inspection Summary

Manhole # S39KK_035MH

Insp Date: **2/28/07 12:02 PM**

Location Address: **1200 LAFAYETTE AVE**

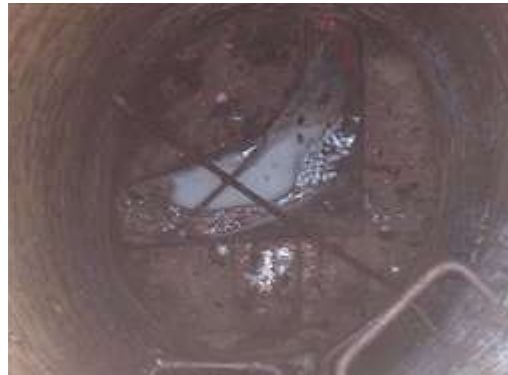
Top View

Barrel infiltration. Evidence of surcharge - Bench debris. Channel debris.

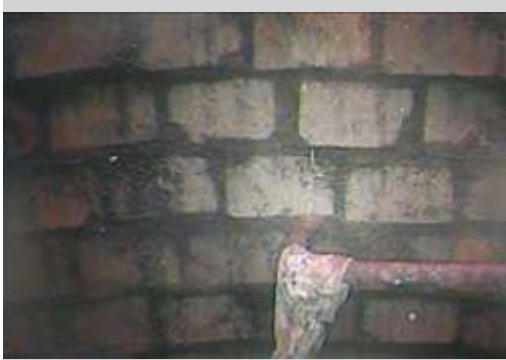
Defect

Count: **7** Missing: **0** ☒ **Corroded**

☒ **Evidence Of Surcharge**

Corroded steps. Evidence of surcharge.

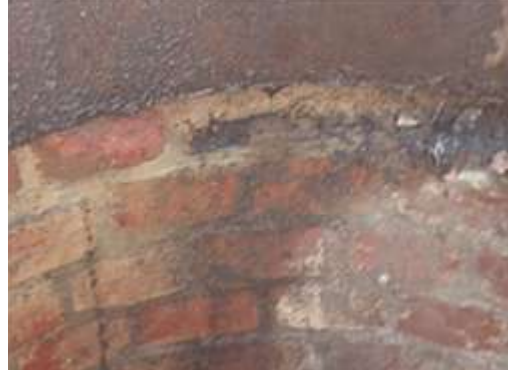
Defect

☒ **Leaks**

Condition: ☐ Sound ☐ Cracked ☐ Root Intrusion ☐ Loose Brick ☒ **Deteriorated**

Infiltration: ☐ None ☒ **Joint** ☐ Cracks ☐ Mortar ☐ Roots ☒ **Wall**

Frame leaks. Adjustment deterioration and infiltration.

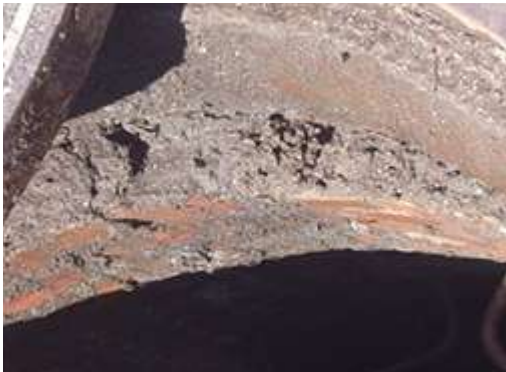
Defect

Offset: **3** (in.)

Frame leaks. Frame offset. Adjustment infiltration.

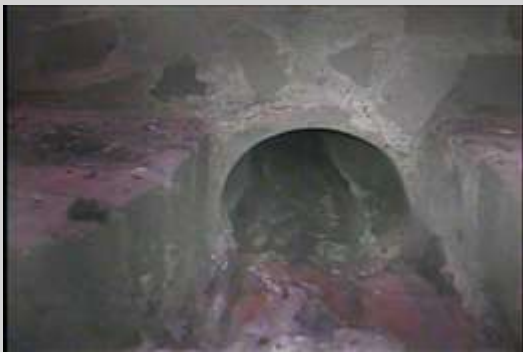
Pipe Out @ 12 O'Clock

Deposits: ☐ None ☐ Mud ☐ Sludge ☒ **Debris** ☐ **Grease**

Silt Depth: **0** (in.) Deposits Extent: **Light**

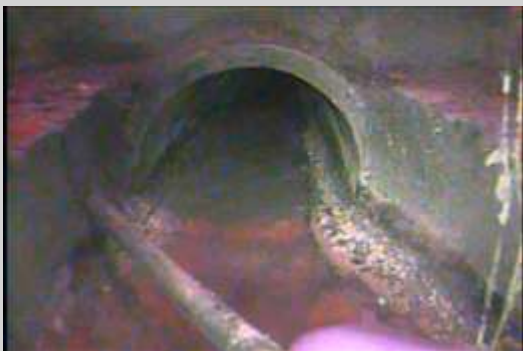
Pipe In @ 9 O'Clock

Deposits: ☐ None ☐ Mud ☐ Sludge ☐ Debris ☒ **Grease**

Silt Depth: **0** (in.) Deposits Extent: **Light**
